## An Archaeological Watching Brief at the Village Hall, Alderwasley, Derbyshire

**ARS Ltd Report 2010/32**

April and May 2010

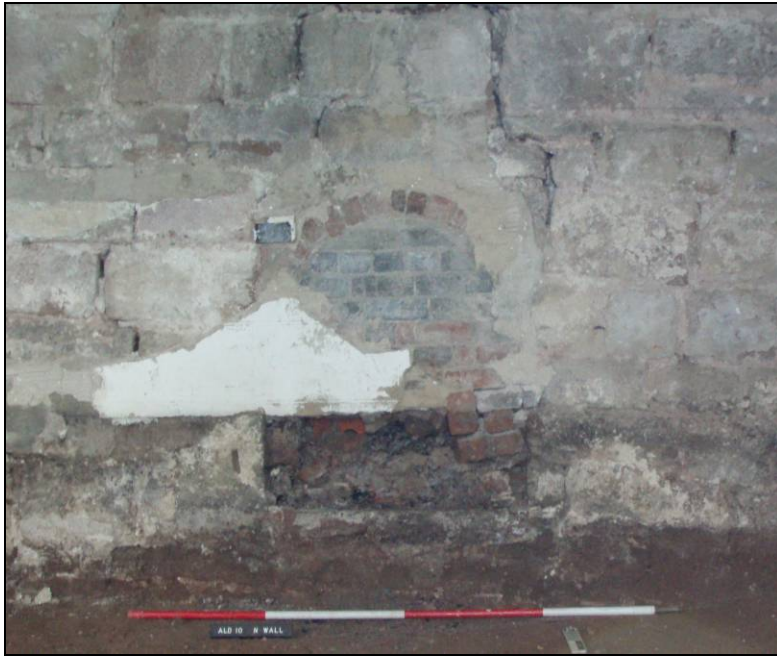
- 5.1.3 The small arched fireplace measured 1.42m x 0.92m (Fig. 4). It had originally been constructed from red bricks and subsequently blocked with blue engineering bricks and red bricks. The substantial cracks in the wall above the fireplace probably indicate the location of the cavity for the chimney flue that was inserted into the original masonry.

Figure 4 Inserted brick fireplace in north wall following the removal of flooring. (Scale: 2m)

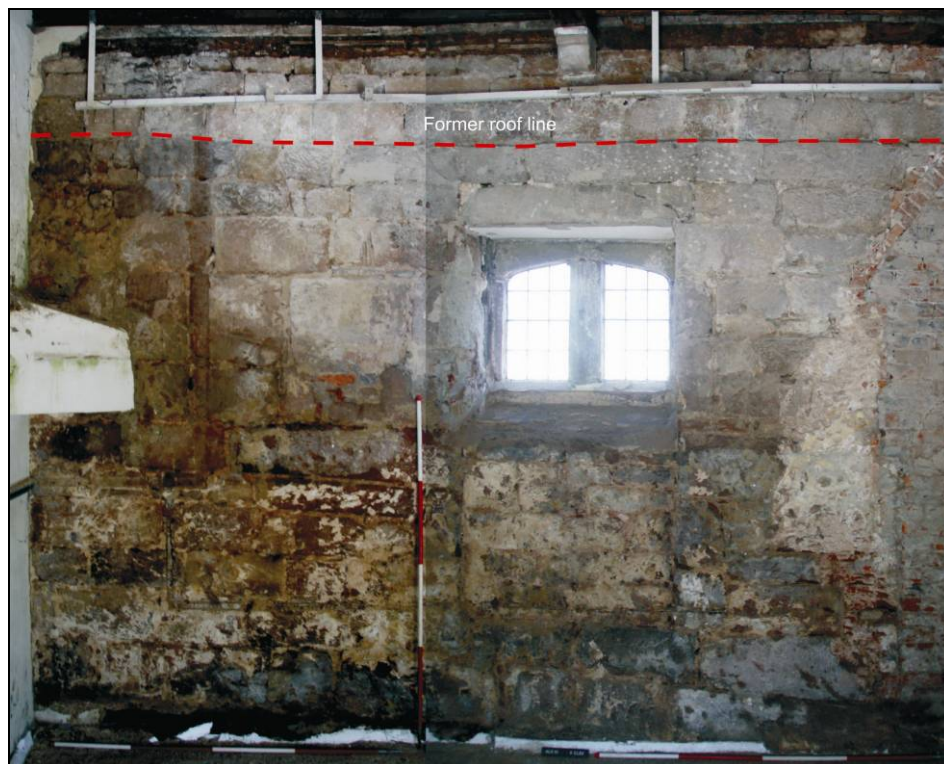
- 5.1.6 A partially blocked window opening was located 1.3m west from the end of the brick infill (Fig. 6). The opening contains a window within its upper section which measured 1.45m x 1.12m and consisted of a small two-light chamfered mullioned with a segmental arched head. The masonry below the window indicates where the entire window opening has been blocked. The original window would have measured 2m by 1.4m and would have been positioned 0.54m above the modern ground level. The blocked up area does not reach the floor level which implies that the opening originally was a larger window, rather than a doorway as argued by Sheppard (2008, 10). The opening on the whole also appears too small to have been a doorway and as it is the only window on this side of the Hall it seems likely that it has always been a window.

- 5.1.7 The horizontal darker, thicker line, evident within the masonry above the window, represents the former roof line which was raised during the 16<sup>th</sup> century (Fig. 6 and Fig. 25 Appendix I). The vertical groove to the west of the window is a modern feature and previously housed electric ducting.

- 5.1.8 Three stone corbels, supporting the timber roof beams, were located along the top of the wall approximately 3m apart in distance (Fig. 6 and Fig. 25 Appendix I). A timber beam measuring approximately 0.15m in thickness was found to run horizontally between these corbels at the top of the wall within the masonry (Fig. 6 and Fig. 25 Appendix I).

Figure 6 Window opening at the western end of the north wall with lower section blocked up. (Scale: 2m)

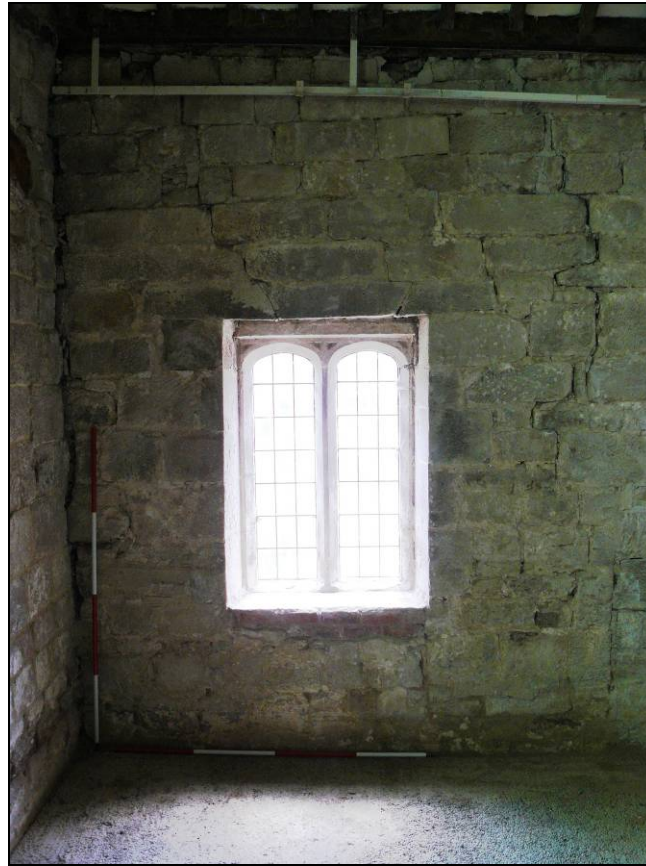
- 5.2.1 The southern elevation was found to contain the main double doorway, three windows and a blocked doorway (Fig. 25 Appendix I). The windows were all two-light chamfered mullioned in stone frames. The window at the eastern extent of the elevation was different from the other two in regards that its position within the wall was lower than the other two; approximately 1m from the floor level compared with 1.45m (Figs. 7, 8 and 9). The window also had two segmental arches which is consistent with a late Perpendicular style rather than the flat style of the other two windows that became common after the mid-15th century. The lower window is therefore more likely to be an original window as it has an earlier style and its lower position compares with the blocked doorway and the general height of the building prior to it having the roof raised (Fig. 9). Also, from the exterior of the building the surrounds of the two later windows show clear signs of having been inserted into the primary walls (Fig. 10).

Figure 7 Original window located at the eastern end of the southern wall. (Scale: 2m)

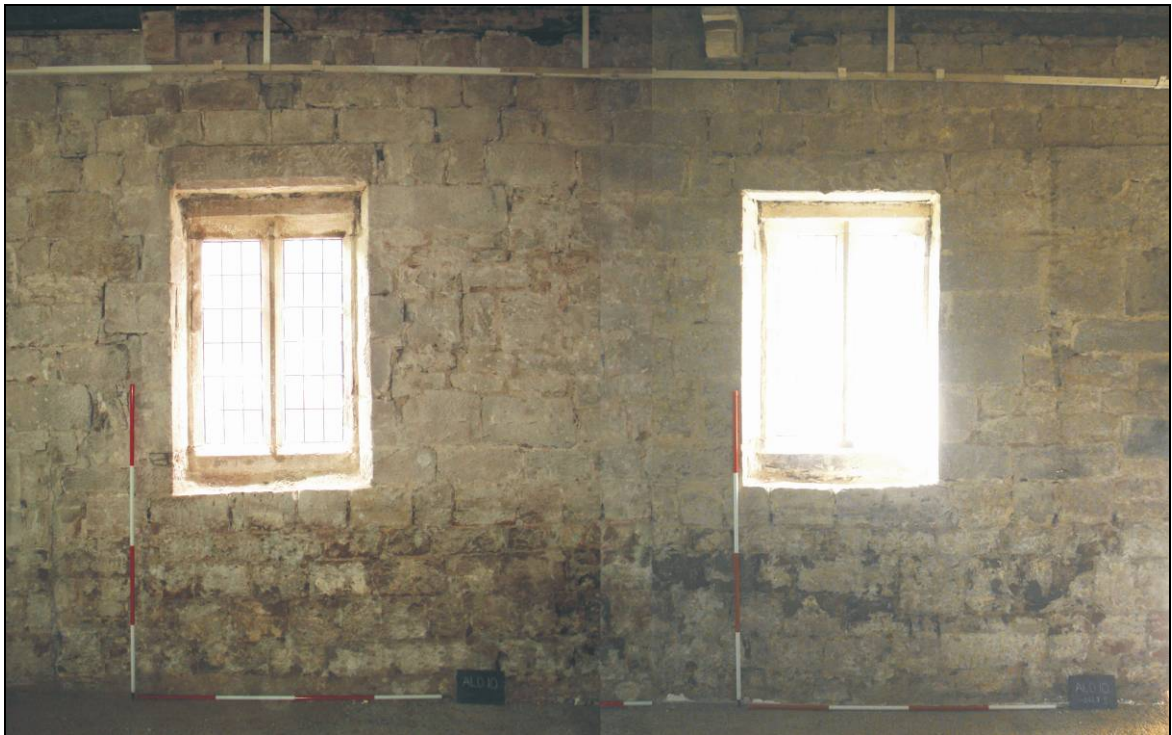
Figure 8 The two later windows within the southern wall. (Scale: 2m)

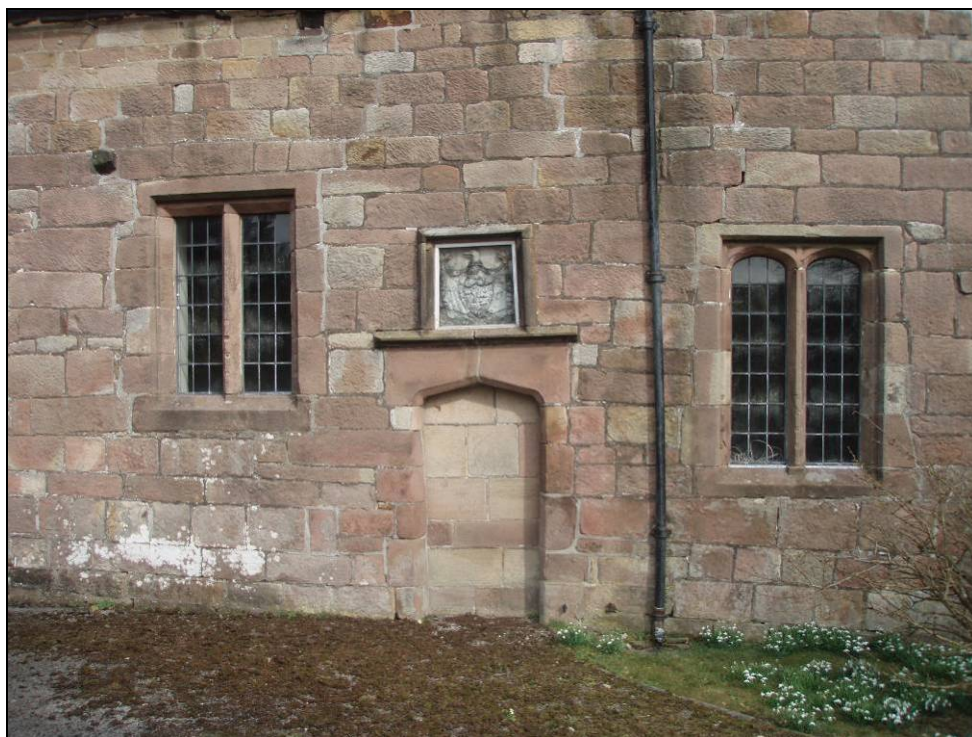
The Hall is a single-storey rectangular-shaped structure, about 17m long and approximately 8m wide (Fig. 2). It is constructed from large red sandstone blocks, laid to fairly regular coursing, with moulded copings to gables and *cyma reversa* kneeler stones and a stone slated roof. There is some variation with the thickness of coursing and irregularity in arrangement of the stonework. This is due to the fact that the chapel was built on a slope and used large quadrilateral shaped blocks for its lower courses that effectively levelled up the higher courses which were made up of smaller rectangular shaped blocks of differing sizes (Fig. 9).

Figure 9 Exterior of south wall showing height difference between the windows and the lower sloping quadrilateral shaped lower courses.

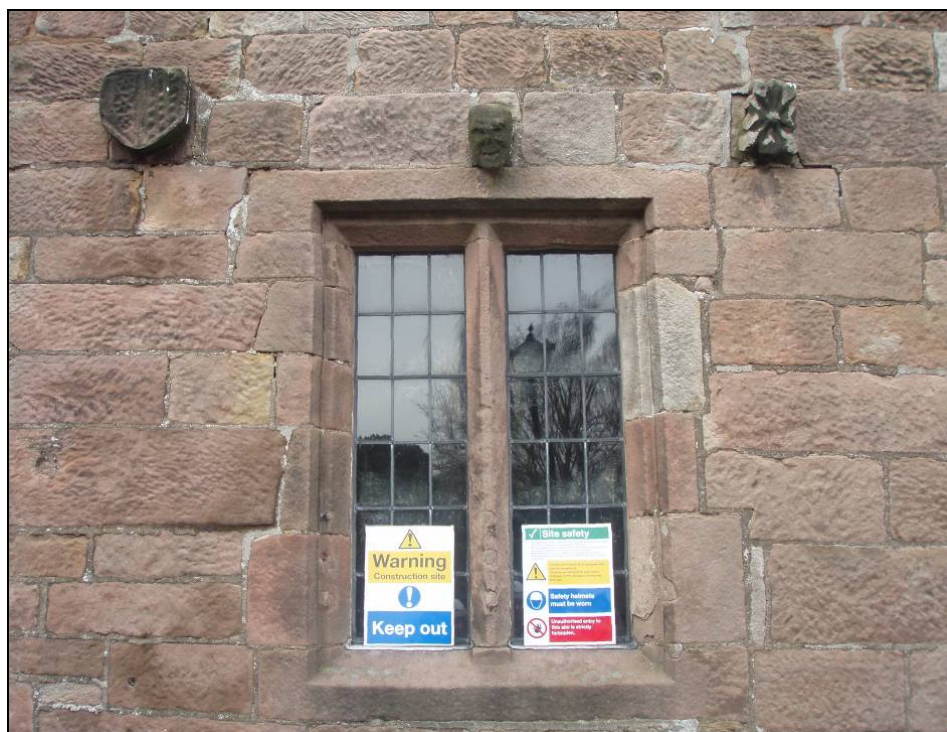
Figure 10 Exterior of south wall showing inserts around the later windows.

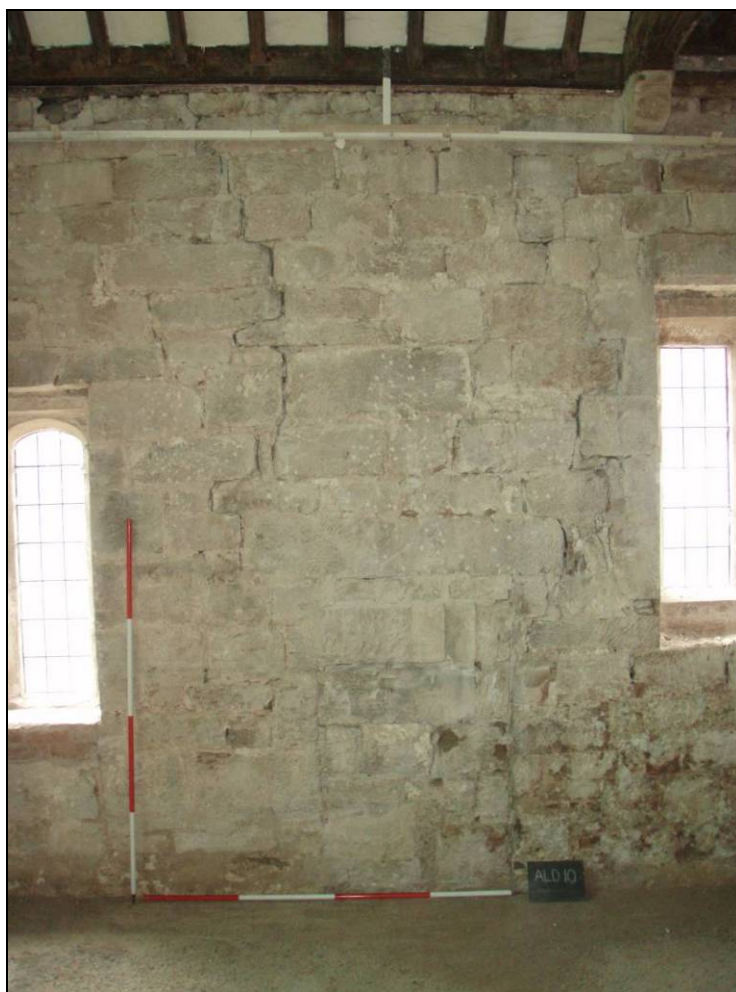
- 5.2.2 The blocked doorway was probably a small priest's door into the chancel and was located 1.1m west from the lower window (Fig. 11). The doorway can be distinguished by a large stone lintel that was positioned 1.7m above the modern floor level (Fig. 25 Appendix I). When the ground level was reduced during works to remove the Victorian floor the blocked doorway was found to exist another 0.6m below the ground level which corresponded to a layer of intermittent plaster on the wall that indicated the height of the earlier floor level.

Figure 11 Blocked doorway in the south wall. (Scale: 2m)

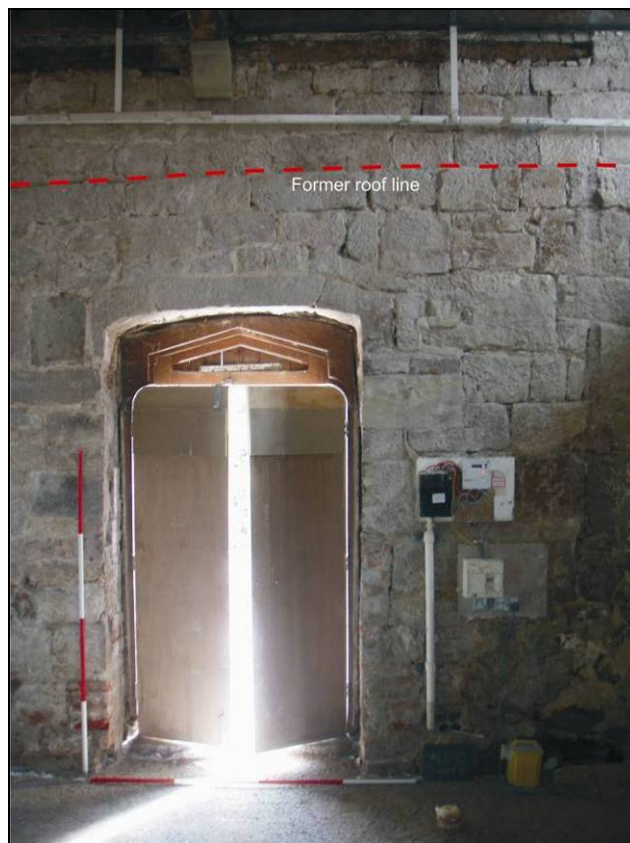
- 5.2.3 The main double doorway for the Hall was located 1.55m from the westernmost window and would have opened into the nave (Fig. 12). The doorway opposed the partially blocked window within the northern elevation.
- 5.2.4 Three stone corbels, supporting the timber roof beams, were located along the top of the wall approximately 3m apart in distance (Fig. 25 Appendix I). A timber beam measuring approximately 0.15m in thickness was found to run horizontally between these corbels at the top of the wall within the masonry (Fig. 25 Appendix I).

Figure 12 Main double doorway within the southern wall. (Scale: 2m)

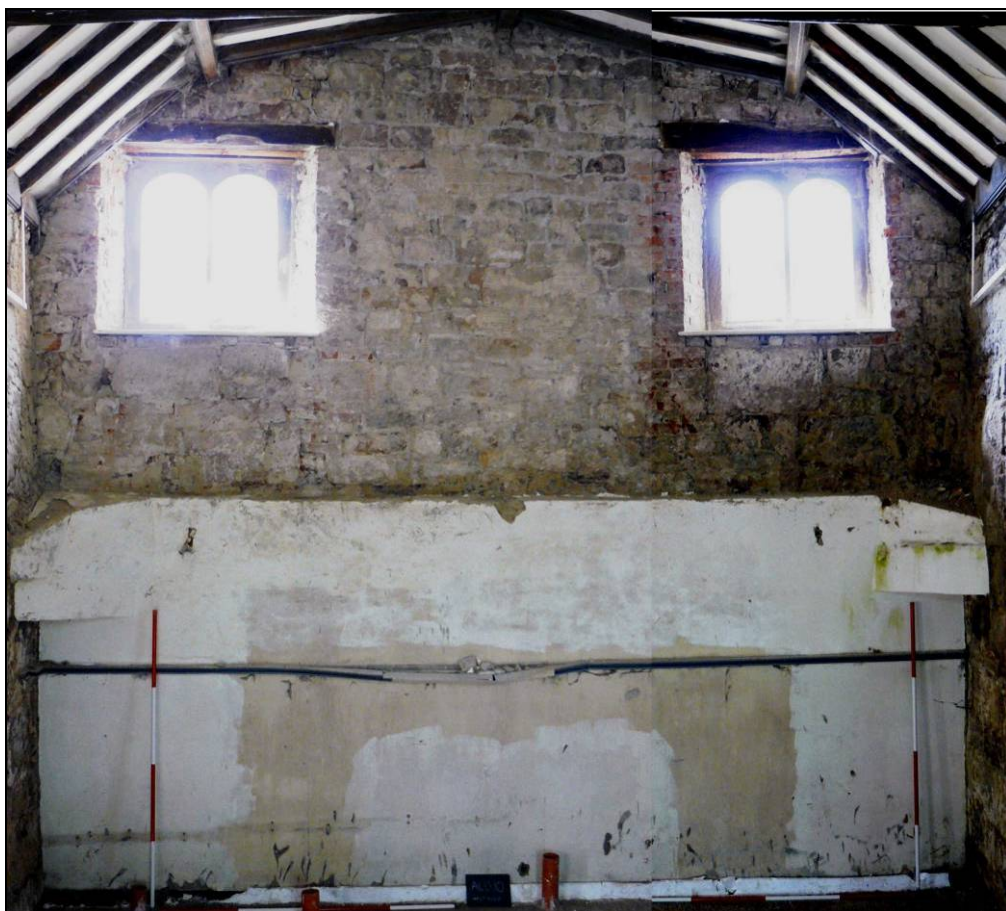
- 5.3.1 The upper half of the western elevation contained two, two-light chamfered mullioned windows with segmental arches in stone frames with timber lintels (Figs. 13 and 26 Appendix I). The windows both measured approximately 1.5m x 1.4m and were located 3.7m above the modern ground level. A mid-19<sup>th</sup> century photograph by Alice Hurt shows a former doorway was once located between these two windows but no evidence of it now remains within the stonework (Fig. 14). A drawing of the chapel dated 1886 shows that the doorway has been blocked up by this point (Fig. 15). The lower half of the wall remained plastered and had two unusual large corbels in each corner approximately 2m above the ground level. The corbels may have been used to support a gallery, which may have also given access to a bell tower through the blocked doorway.

Figure 13 Western wall showing windows and large corbels. (Scale: 2m)

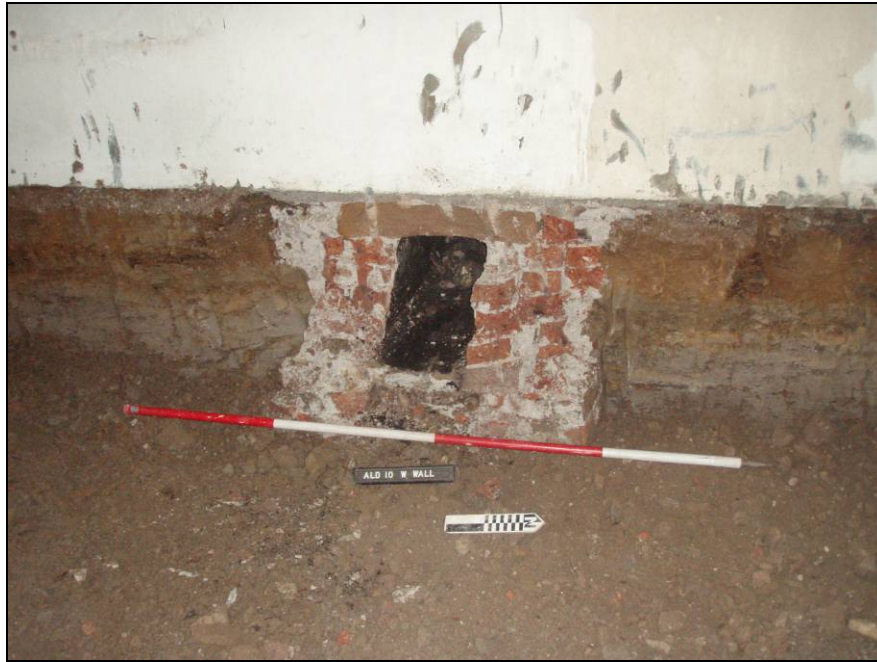
- 5.3.3 When the ground level was lowered the remains of a Victorian drain were found below the lower levels of the western wall within the natural clay (Fig. 16). The drain measured 1m x 0.95m and had been constructed from red bricks with a cement mortar and had a sandstone cap stone. The foundations at this end of the chapel were extremely shallow, the lowest course of masonry overlying the sandstone cap for the drain. The exterior of the Hall at this western end has the hill sloping against it and therefore would probably have been prone to dampness as the compact natural clay would not have been very effective at draining the water. The drain was designed to take any water that built up against this wall under the floor and out the other side of the building. It was probably installed when the Victorian floor level was laid.

Figure 16 Victorian drain located within western elevation below modern ground level. (Scale: 2m)

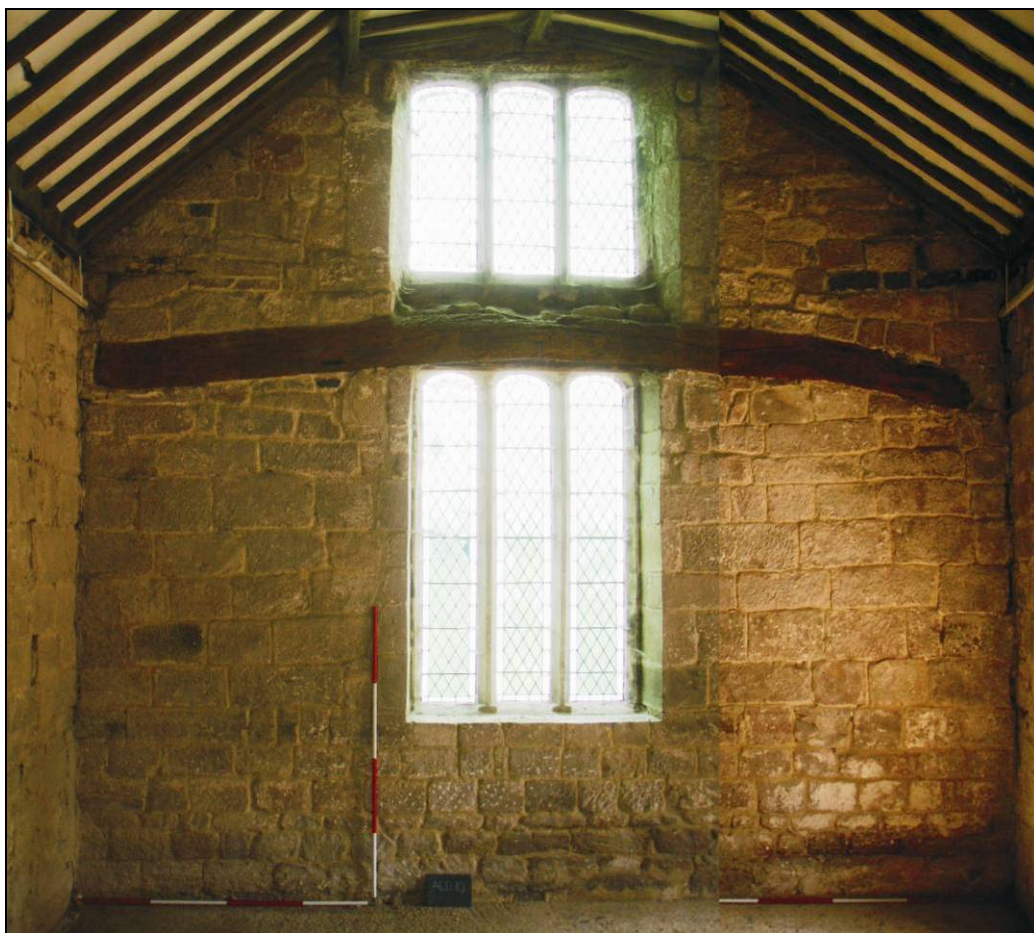
- 5.4.1 The eastern wall contained two large, three light, mullioned windows with segmental arches within stone frames (Figs. 17 and 27 Appendix I). The upper window measured 1.6m x 1.55m and the lower window measured 2.45m x 1.6m. The upper window is slightly different in style from the taller lower window, being slightly wider with flatter arches. This is probably because the upper window would have been added at a later date, possibly when the roof was heightened.

Figure 17 Eastern wall showing windows and timber beam. (Scale: 2m)

- 5.4.3 A large timber beam measuring 6m x 0.3m divided the two windows and ran across the wall approximately 3.7m above the ground level (Fig. 17). Although it was curving and possibly reduced at the south end, the timber might be a surviving tie-beam for an earlier lower roof as it coincides with the former building roof line mentioned above. There were two infilled mortices on either side of the lower window jamb. The stones laid above the timber beam follow its curve suggesting that the beam was an original feature of the wall with the upper part being added later.

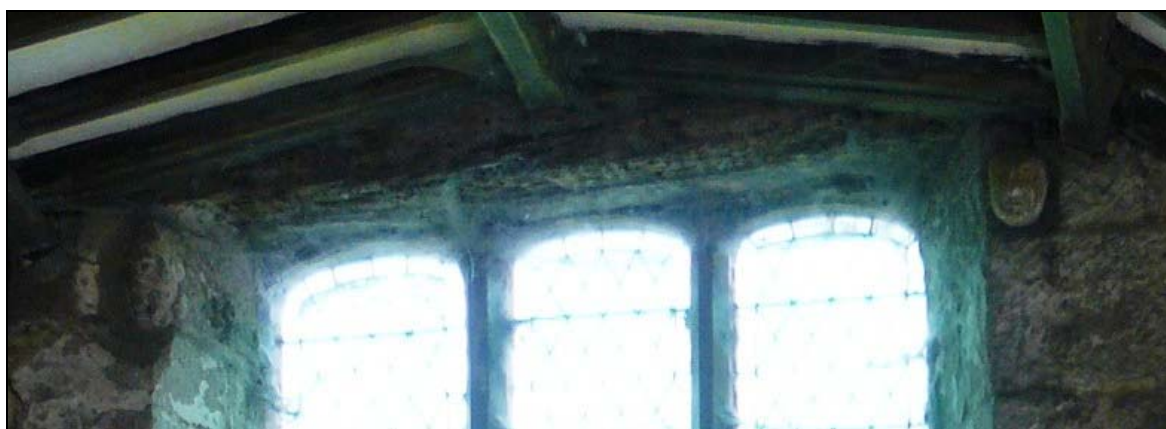
- 5.4.2 The upper windows are flanked by two stones which bear carved stone heads (Fig. 18). These stones show signs of heavy weathering and might have therefore been reset from elsewhere probably when the roof was heightened and the window was inserted.

Figure 18 Stone heads located either side of the top window within the eastern wall.

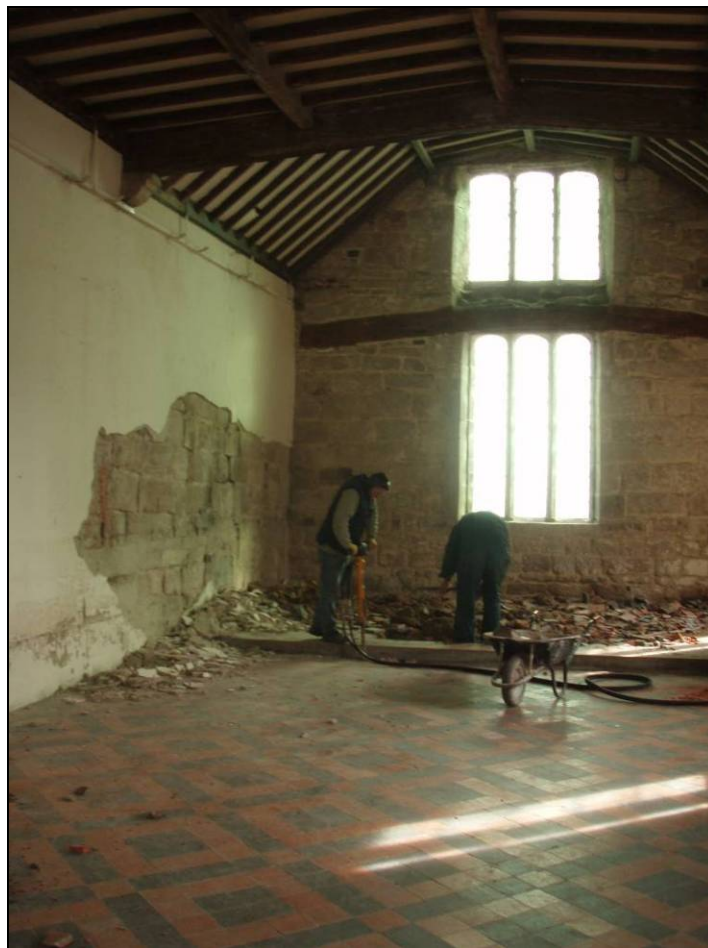
- 5.5.1 During ground works to remove the tiled Victorian floor level evidence for a former floor level was uncovered (Fig. 19). This comprised of a very small area of secondary architectural fragments and an intermittent plaster layer. Two architectural fragments were found in the south-eastern corner of the Hall (Figs. 20 and 28 Appendix I). They included a large sandstone slab that measured 2.9m x 1m which was chamfered on the underside with a groove and a probable moulded roof corbel (Fig. 21). The formal deposition of these architectural fragments may indicate that they were utilised deliberately as part of the lower floor surface. The large sandstone slab broke as it was being moved along the groove where it was the weakest.

Figure 19 Work to remove the Victorian floor level.

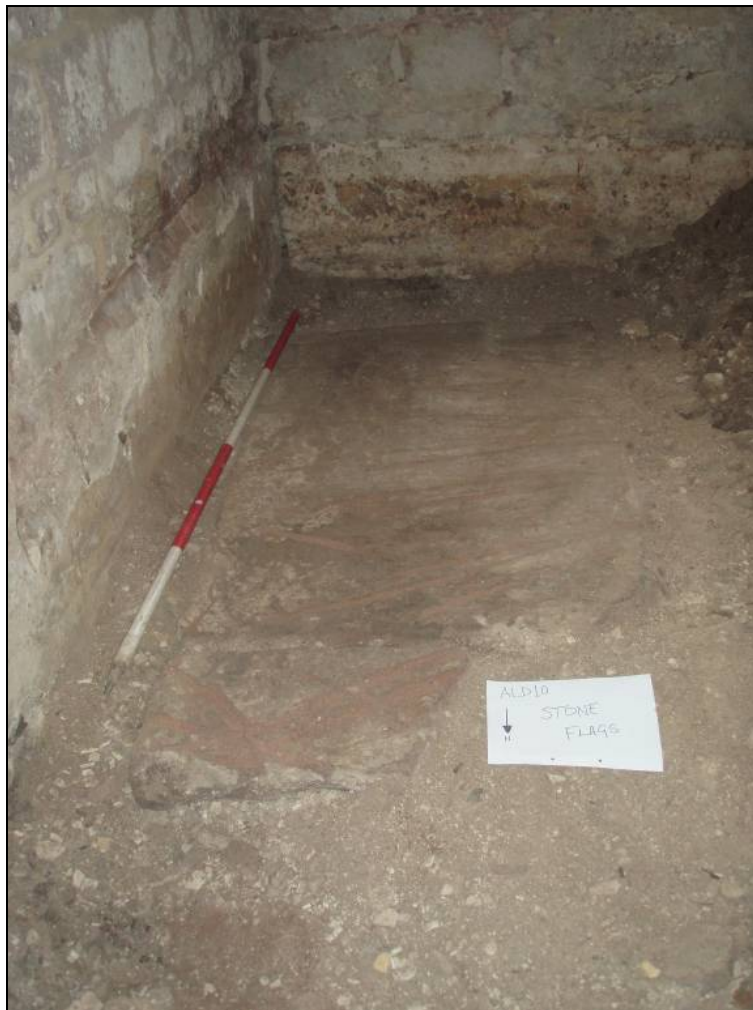
- 5.5.2 The large stone slab did not have any inscriptions or masonry marks to indicate its use although it is suggestive of a base rather than a top due to its thickness; maybe of an altar stone. The stone was most likely turned over and laid in the floor during works to raise the roof in the 16<sup>th</sup>/17<sup>th</sup> century; which would also explain the presence of the probable roof corbel. It is not known whether the groove was an original feature of the stone slab or whether it was added later when it was part of the floor. The rest of the former floor was removed during the Victorian period when the tiles were laid but this slab may have been too large to move and therefore was left as a convenient foundation block for the present floor.

Figure 20 Area of former floor level found in situ. (Scale: 2m)

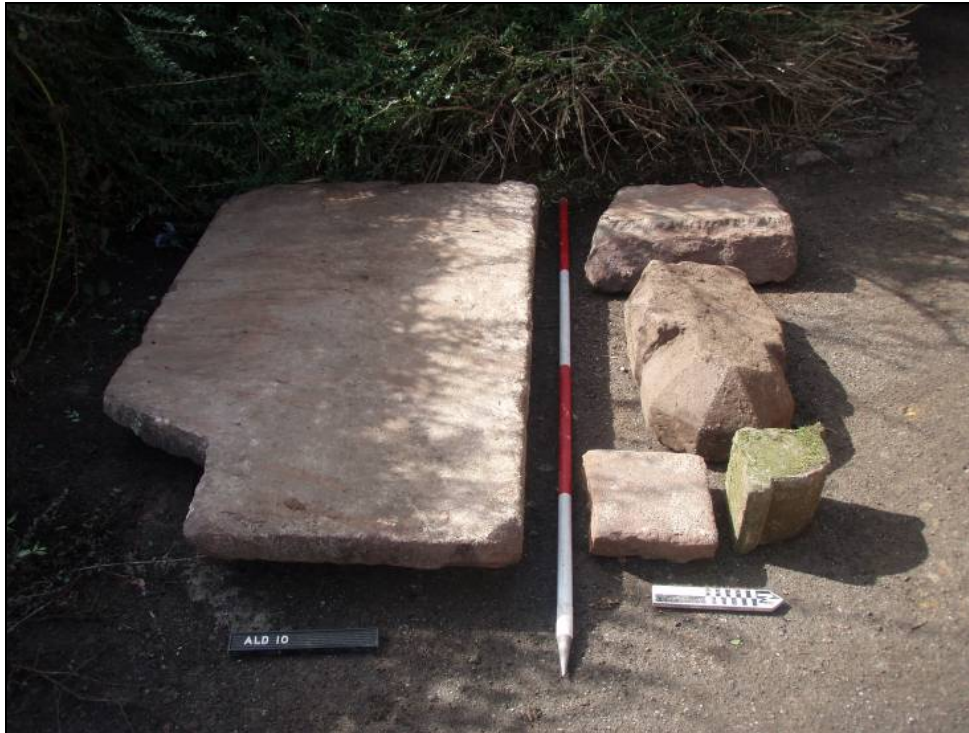
Figure 21 Secondary architectural fragments found as part of the former floor level. (Scale: 2m)

- 5.5.3 A small moulded corbel stone was found outside the building on its eastern side and represents another discarded architectural fragment (Fig. 21). The corbel is identical as the ones currently used on the interior of the Hall and, as a result, contemporary with that phase of construction work (see Figs. 6, 8, 11, 26 and 27 Appendix I).

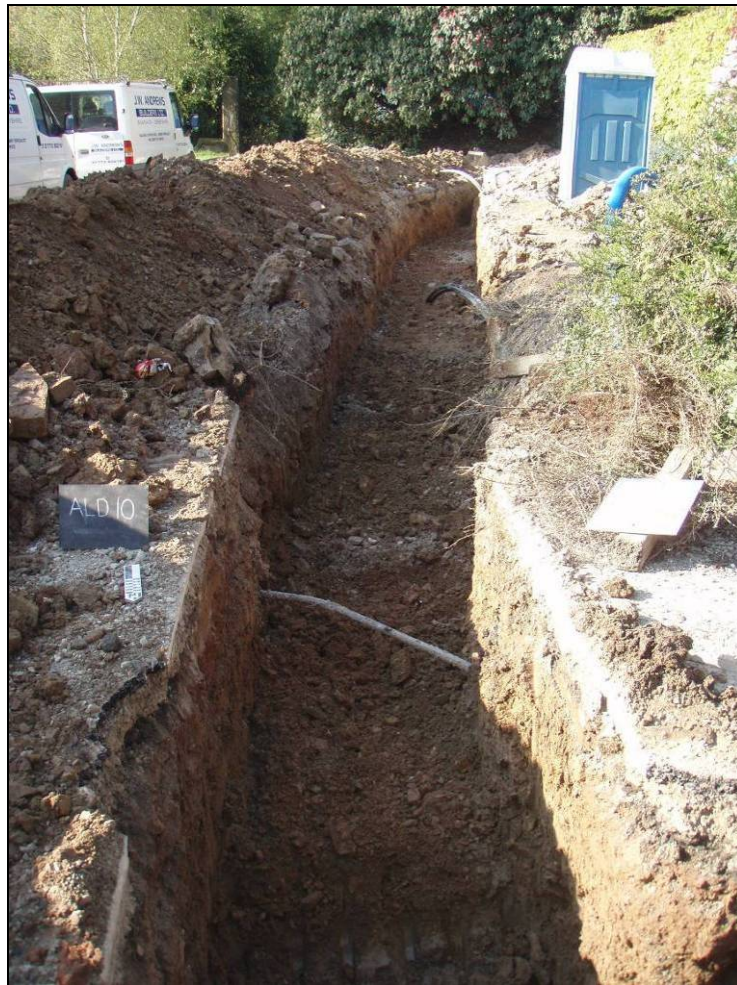
- 5.6.2 The opening of the trench commenced in the south-west corner of the hard-standing area, from the location of an existing manhole. The trench was initially excavated northwards and measured approximately 0.4m wide and 1m deep for the first 5m. Continuing northwards for 21m the trench then turned sharply to run east to west for a further 7m, before terminating by a concrete pad laid adjacent to the Hall entrance. The width of the trench had been enlarged to between 1m and 1.2m with a maximum depth of 1.2m (Figs. 22 and 23).

Figure 23 Post excavation shot of the service trench. (Facing south)

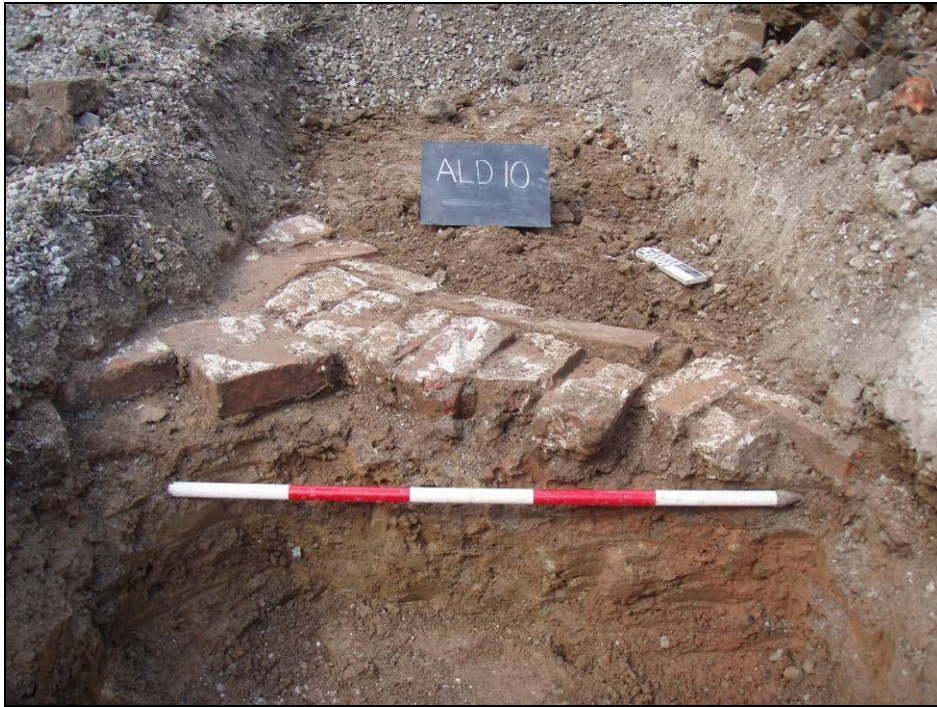
- 5.6.4 Approximately 9m north from the opening of the trench a deposit of red bricks (106) was encountered (Fig. 24); the bricks extended 10m northwards before terminating. Randomly laid on bed in an irregular pattern the handmade bricks measured 8<sup>3</sup>/<sub>4</sub>" x 4<sup>1</sup>/<sub>4</sub>" x 2<sup>3</sup>/<sub>8</sub>", bonding material still attached consisted of a limestone mortar to three faces and a painted cement render to one face. (106) was laid firmly into the natural ground (104) with a lens of natural clay (105) 0.03m in depth re-deposited above them. Overlaying the re-deposited natural clay (105) were the deposits (103), (102) and (101). The bricks (106) were probably laid to establish ground consolidation in an earlier area of hard-standing.

Figure 24 Bricks (106) at their northern termination. (Scale: 1m)

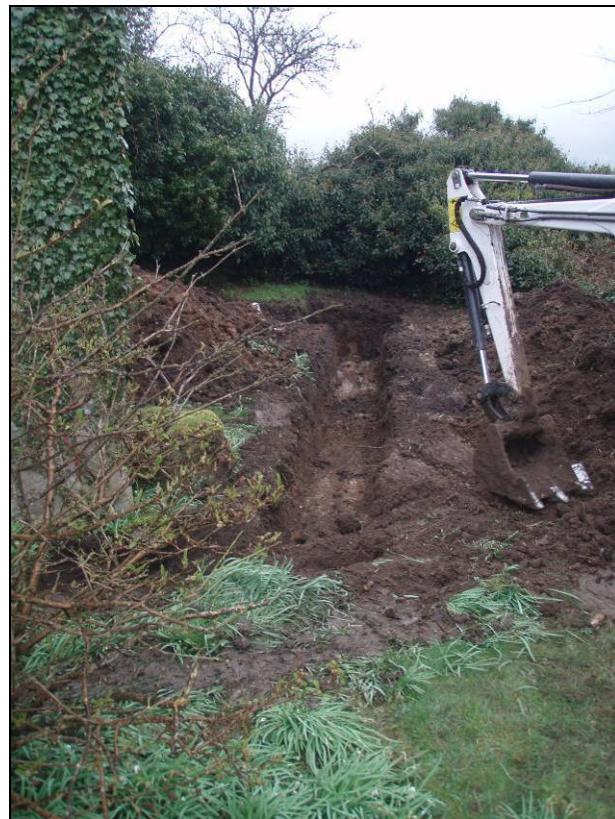
- 5.6.6 A small drainage trench and soak-away were excavated on the eastern side of the Hall. The trench measured 5m long x 1m wide and was between 0.6m and 0.8m in depth (Fig. 25). The soak-away measured 1.5m x 1.5m and approximately 1.75m in depth. The ground was found to contain the same stratigraphy as discussed above.

Figure 25 View of the trench and soak-away. (Looking north)
